079-4186

**2006-01 Ford Escape; Mazda Tribute; 2006-05
Mercury Mariner**

O-Ring and Gasket Issues May Be Causing a Misfire

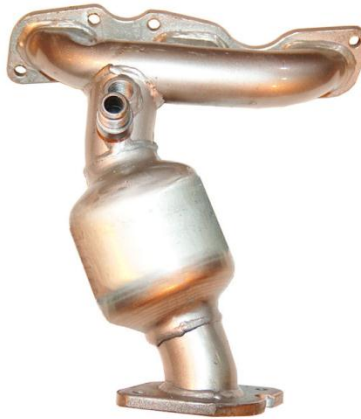
O-Ring failure in the area of the intake manifold and EGR valve on certain Escape, Tribute, and Mariner applications may be causing a vacuum leak and eventual misfire condition, which could be the root cause of the original converter failure.

Prior to converter replacement, it is recommended that the gasket and O-Ring between the EGR valve and intake manifold be replaced with the manufacturer's updated version. Failure to replace / update the gasket and O-Ring can leave the vehicle susceptible to repeated converter failure from the original problem.

In addition to the above, confirmation of a fully operational coil-on-plug system is recommended prior to catalytic converter replacement.
