CARDONE® ProTech®

Transfer Case Motor Typical Failures and Prevention

Chevy/GMC, Ford, Mazda and Isuzu 4-wheel drive vehicles equipped with Transfer Case Motors.

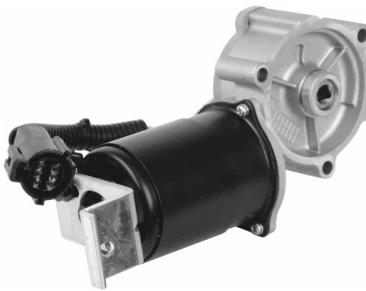
Typical Ford Motor

Ford applications require transfer of wire connector pins. Be sure to record pin location before removing the original unit.

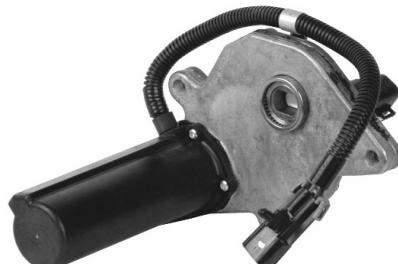
Typical GM Motor

Replacement motors for GM vehicles are supplied in 2-wheel drive position. If necessary, select or move transfer case into 2-wheel drive before installation of replacement motor. GM applications will require a scan tool to clear the codes from the transmission control module (refer to the vehicle service manual for correct tool and procedures).
