Brake Rotor Installation Tips

To assure pulsation free performance over the life of your brakes

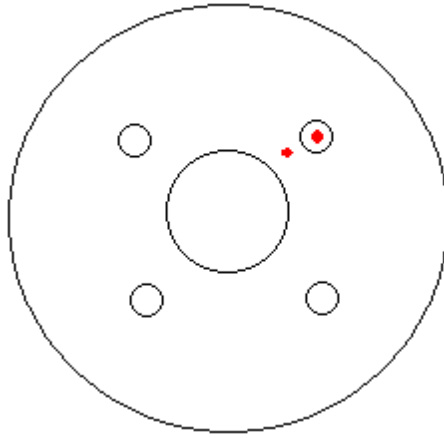
- Confirm that the hub and rotor mating surfaces are clean and free of any rust, dust, or other debris, install the rotor onto the hub, and mark the initial position with a paint mark on a lug stud and next to the corresponding lug hole.

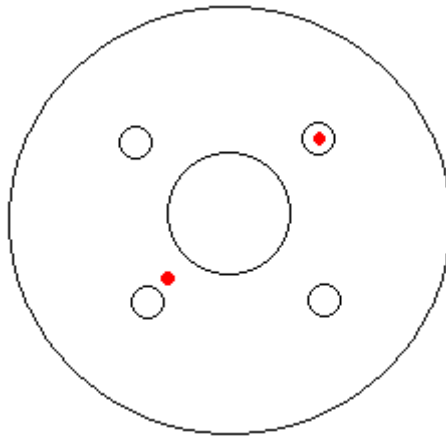
- Next, remove the rotor and install in a different position on the hub:

Measure runout and record results once again. If the results from both measurements match in both location and amount of runout measured, then excessive runout exists in the rotor itself, and the rotor requires either replacement or machining.
