TECH TIP COOLING SYSTEM

BULLETIN TT006-16

Automotive Sealant Use During Water Pump Replacement

Water Pump Failure Signs

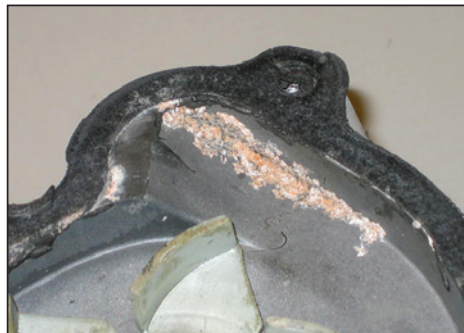
DEPOSITS/CALCIUM BUILDUP

If during the course of an inspection the water pump is found to look like any of the below, Gates recommends properly flushing the system, filling the system with a new mixture of the correct coolant, and possibly replacing the water pump depending on the issues found.

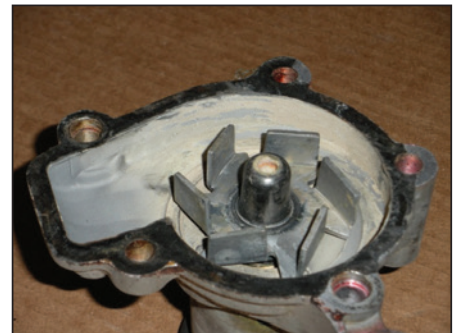
DEPOSITS/CALCIUM BUILDUP

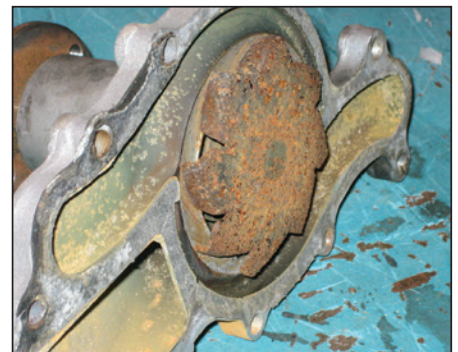
RUST/CORROSION

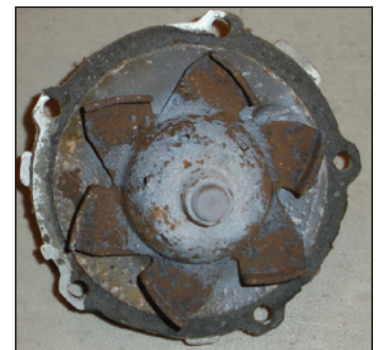
RUST/CORROSION
