## Brake Rotor Installation Tips

**To assure pulsation free performance over the life of your brakes**

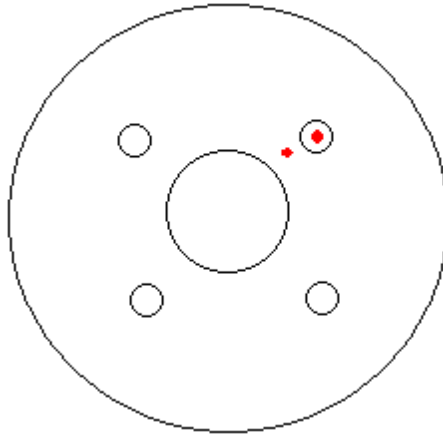
- Confirm that the hub and rotor mating surfaces are clean and free of any rust, dust, or other debris, install the rotor onto the hub, and mark the initial position with a paint mark on a lug stud and next to the corresponding lug hole.

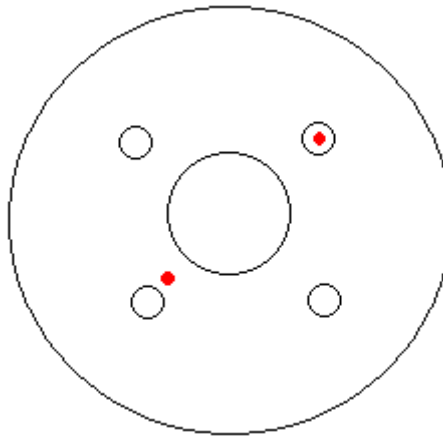
- Measure rotor runout, recording the ZERO location and the high spot location, as well the amount of runout on the surface of the rotor with a marker.
- Next, remove the rotor and install in a different position on the hub:

Measure runout and record results once again. If the results from both measurements match in both location and amount of runout measured, then excessive runout exists in the rotor itself, and the rotor requires either replacement or machining.

- If the results from both tests are marked in different locations on the rotor, then runout exists in the hub. If this is the case, cleanliness of mating surfaces should be confirmed once again, and then hub runout measured to confirm previous results. Any measurable hub runout requires hub replacement or a more short term solution of machining the disc on the hub using an on-car lathe. An on-car lathe will yield a finished product that compensates for any hub runout and if done correctly, will result in a rotor with ZERO installed runout when mounted to the hub in the same position in which it was machined. Any hub runout will show up as a considerably higher number when measured at the edge of the rotor....the larger the rotor, the greater the increase in measured runout.
